Carol Stream Park District
Evergreen Lakes Bank Assessment
Summary Report

849 W Lies Rd
Carol Stream, IL 60188
Bodwé Project No. 24-2055
Issued for Carol Stream Park District – October 2024

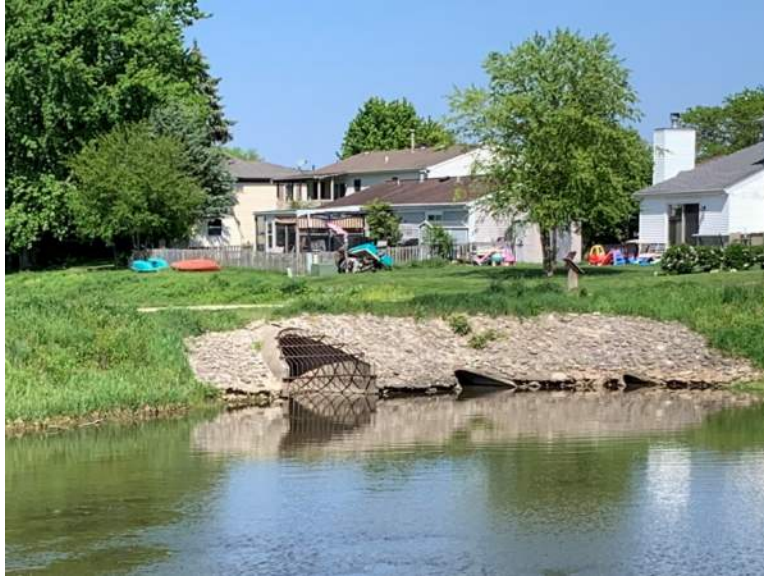
The bridge section between the North and South Lakes is in good condition. There is existing structural reinforcement surrounding the culverts and vegetation buffer, pictured in Figure 2.1.

Figure 2.1 Category A – Culverts Between North and South Lakes, 1-5

Category A sections of the bank appear to be in good condition and do not require additional erosion control methods at this time. However, vegetation in these areas should be regularly maintained to ensure this good standing.

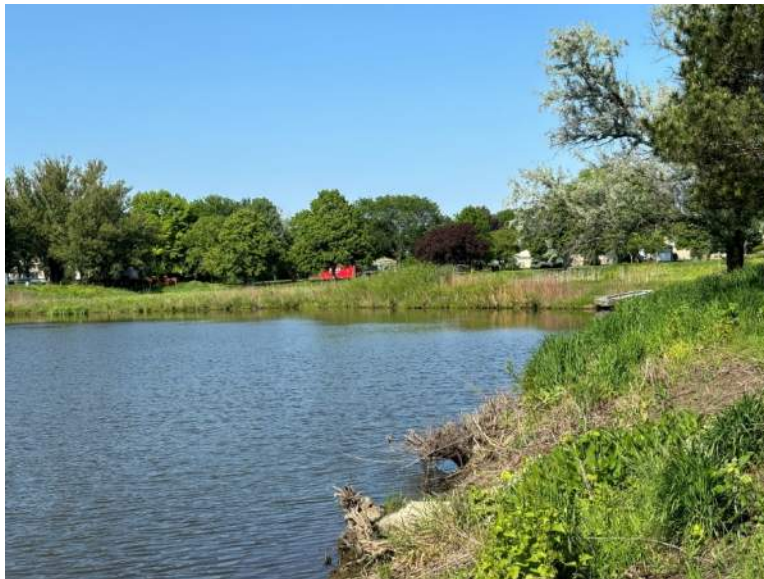
The North Lake is generally in better condition than the South Lake; there is less erosion comparatively and no instances of category C erosion. There is adequate vegetative cover throughout including a wetland portion of the North Lake in the northeast corner, shown in Figure 2.2 and Appendix B - Figure 1.

Figure 2.2 Category A – Wetland Area, 10-N

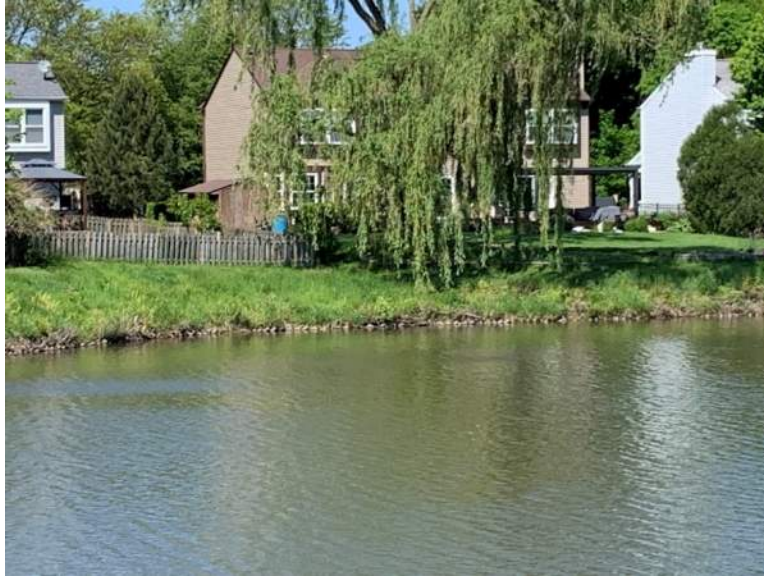
There is also existing structural enforcement present in the form of A-Jacks along the northern-most portion of the bank. These are generally in good condition and providing some bank protection, as seen in Figure 2.3. However, the A-Jacks in some places are sitting in front of the shoreline, indicating that some erosion has still occurred with them in place, seen in Figure 2.4.

Figure 2.3 Category A – Existing A-Jacks Enforcement, 5-N

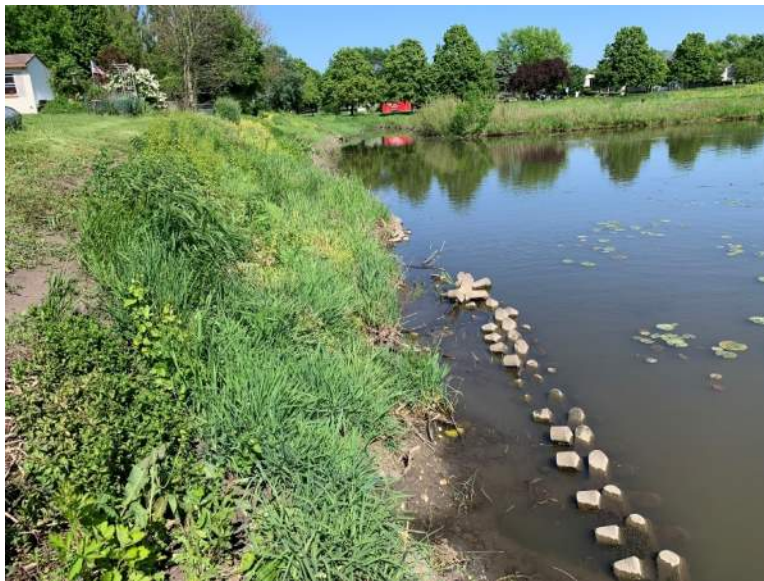
Figure 2.4 Category B – Existing A-Jacks Enforcement, 6-N

At Category B sections of the bank, bio-engineered/soft treatment methods such as bio-logs, live staking, and/or seeding with erosion control blankets would be adequate. These methods are applicable for areas with less threat of erosion and require less engineering effort.

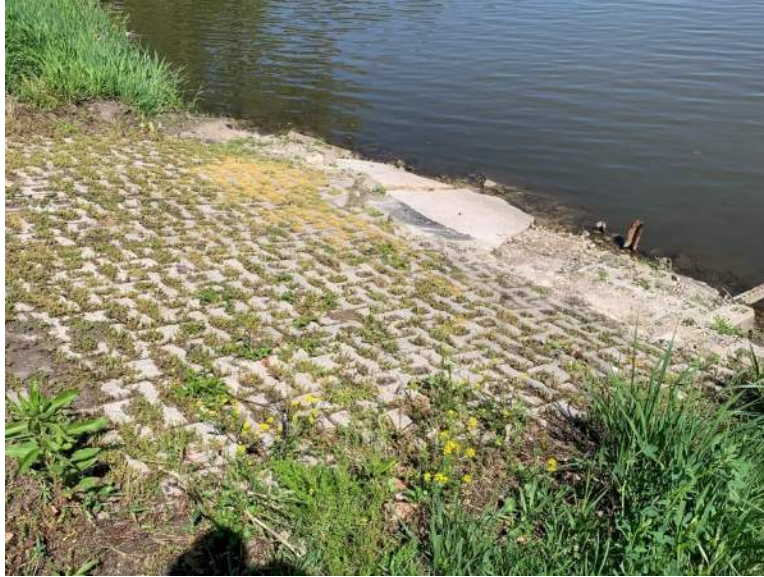
There is also an existing boat launch for non-motorized boats at the northwest corner of the lake, pictured in Figure 2.5. This launch was graded Category B because of the observed damage at the shoreline.

Figure 2.5 Category B – Existing Boat Launch, 4-N

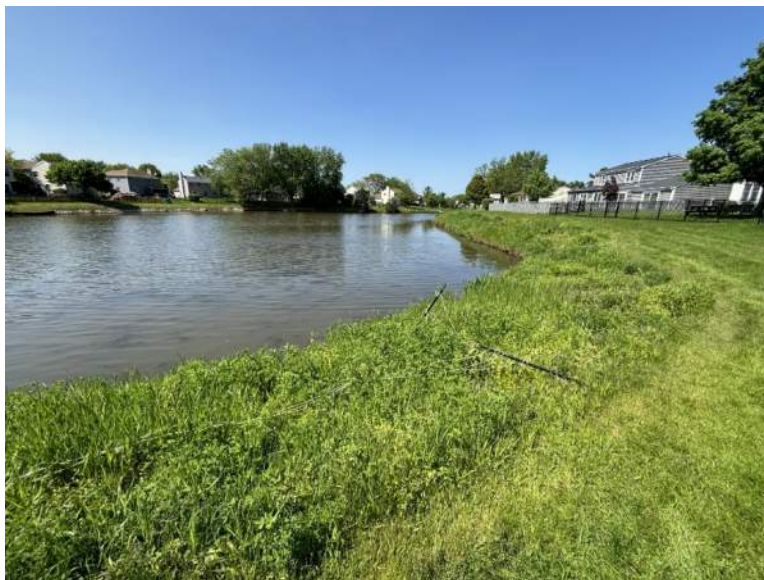
The South Lake generally has more erosion than the North Lake and has been a specific area of concern for the park district. The banks are generally steeper and there is a lack of native plant growth in the southwest portion. Erosion is present at the northeast portion and near the outlet culvert at the southernmost portion of the lake. There is a small section of adequate bank at the southeast corner where the shoreline is a significant distance from the surrounding properties, shown in Figure 2.6.

Figure 2.6 Category A – Gradual Slope, 4-S

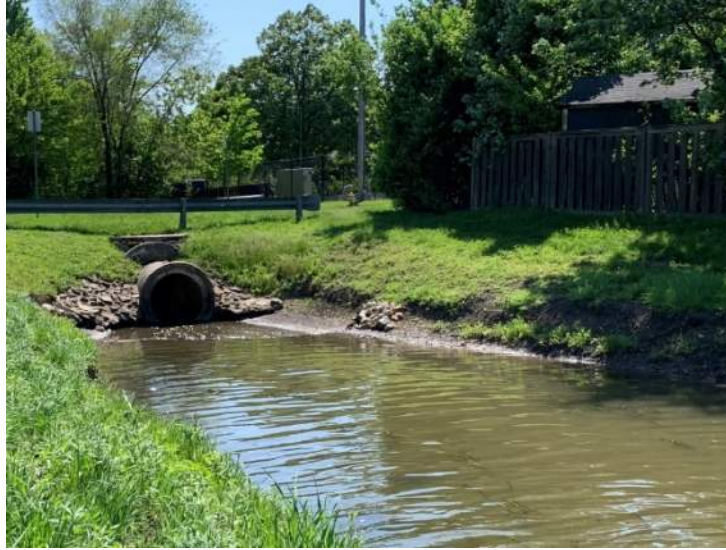
The outlet culvert is rated Category C because of the observed steep slope, lack of vegetation and distance to property line, seen on the right side of the image in Figure 2.7.

Figure 2.7 Category C – Outlet Culvert, 6-S

Due to the erosion of the Category C bank areas on Evergreen Lakes, these sections may best be treated with a structural/hard armor treatment. This includes a combination of stone toe stabilization and a form of vegetative erosion control (live stakes, live fascines, and/or encapsulated soil lift), such as what was shown in Figure 3.5, Figure 3.6, and Figure 3.7. This provides an armored bank toe that can manage significant erosion long-term. When armored toe is combined with vegetation, erosion is additionally minimized, and aesthetic and environmental benefits are provided.

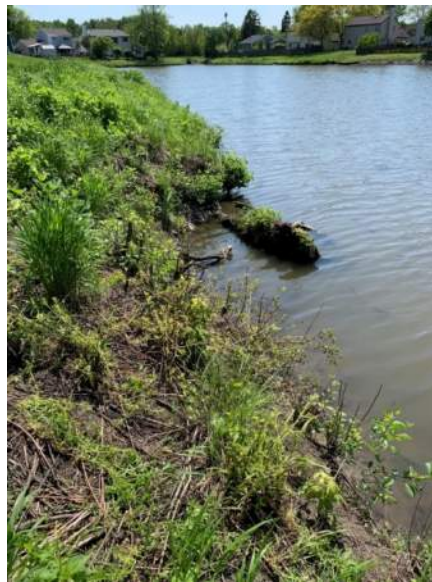
There is a significant amount of downcutting (downward or vertical erosion) along banks in the South Lake, shown in Figure 2.8 and Figure 2.9.

Figure 2.8 Category B – Downcutting, 3-S

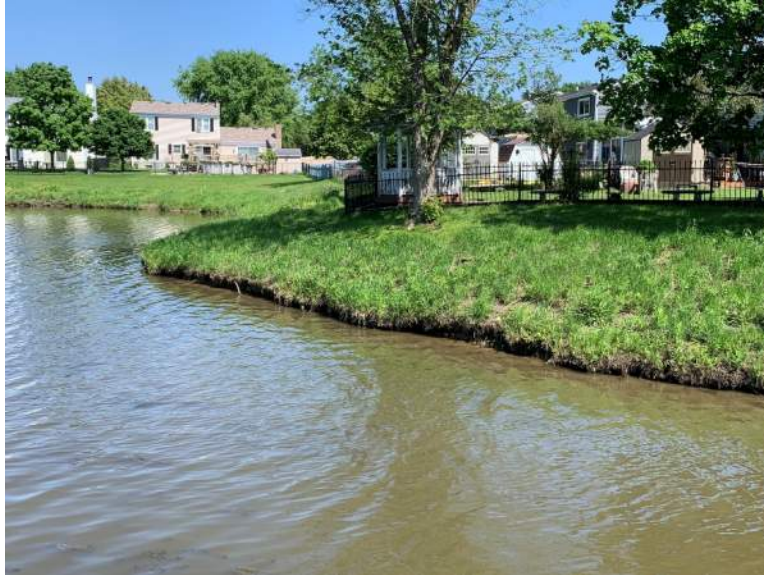
Figure 2.9 Category B – Downcutting, 5-S

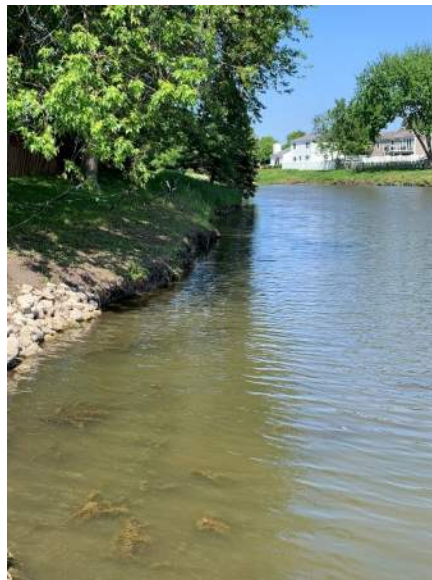
Figure 2.10 shows steep downcutting at a Category B location but based on historical aerial imagery, the bank has not receded appreciably. Tree root structure at this location appears to help maintain a fairly stable bank. Figure 2.11 shows Category C downcutting and limited distance to the property lines and more sparse vegetative growth compared to other portions of the bank.

Figure 2.10 Category B – Downcutting, 9-S

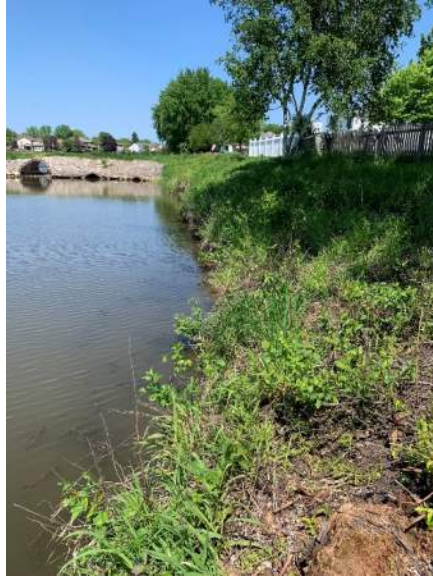
Figure 2.11 Category C – Downcutting, 2-S

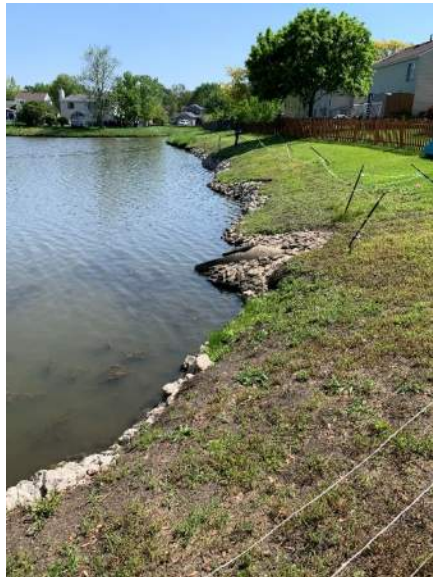
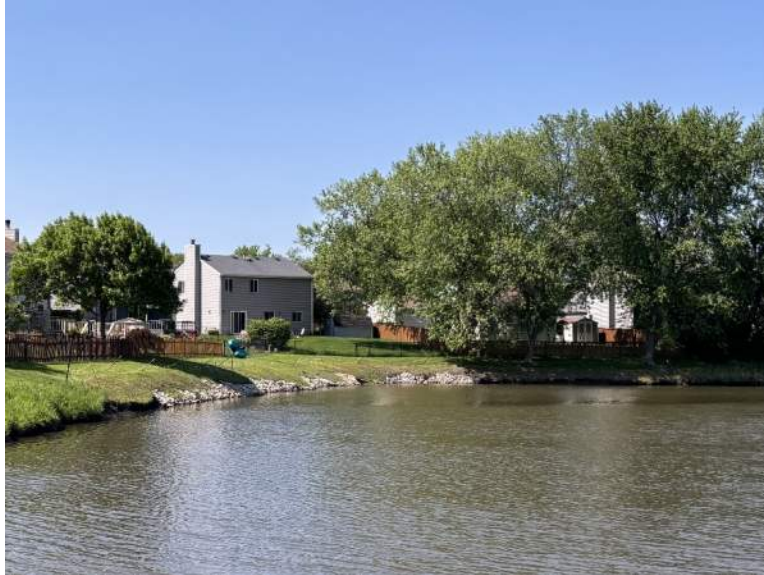
Additionally, there is existing riprap at the southwest portion of the South Lake, shown in Figure 2.12 and Figure 2.13. However, this stabilization is not accompanied by native plant growth and is at a steep grade, so it is still an area of concern.

Figure 2.12 Category C – Existing Riprap, 8-S

Figure 2.13 Category C – Existing Riprap, 8-S

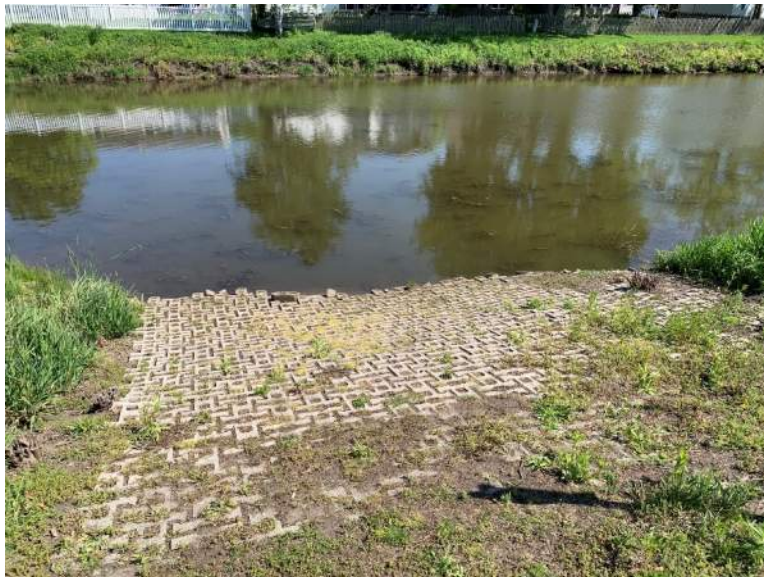
There is another existing boat launch on the South Lake at the northwest corner which is in good condition, pictured in Figure 2.14. The launch is generally stable and surrounded by vegetation on either side.

Figure 2.14 Category A – Boat Launch, 1-S
